Flood Control Project Maintenance
2014 Structure Summary Report
Overall Unit and Item Ratings

City of Sacramento

El Camino Avenue Bridge

Flood Control Project Maintenance
Unit Cover Sheet
2014 Structure Inspection Results

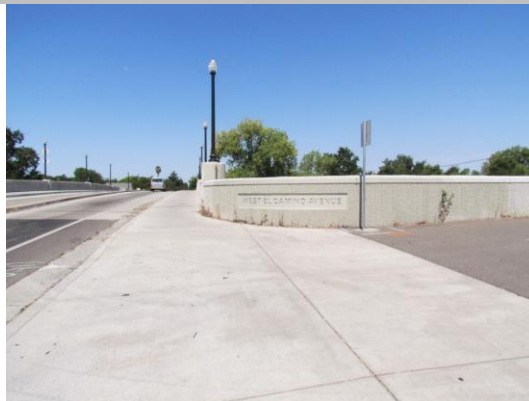
Photo 1 of 1 : ST_2014_NA0005_221_1_20140721_00020.jpg

LM Start	0.00	Rating **	N	Issue No.	1	
LM End	0.00	Issue Type +	Ma	Location *		
Category	Structures & Concrete Lined Channels			GPS Latitude/Longitude		
				Start	End	
Item	Photo Documentation			38.611365 °	38.611365 °	
				-121.466557 °	-121.466557 °	
DWR ID	DWR_NA0005_221_t_2012_1					
Action/Comments						
Inspector Comments: West El Camino bridge is inspected as a structure because the bridge deck is below the design water surface elevation causing the wingwalls and guard railing to act as flood walls during high water events.

View of the bridge which acts as a flood wall.

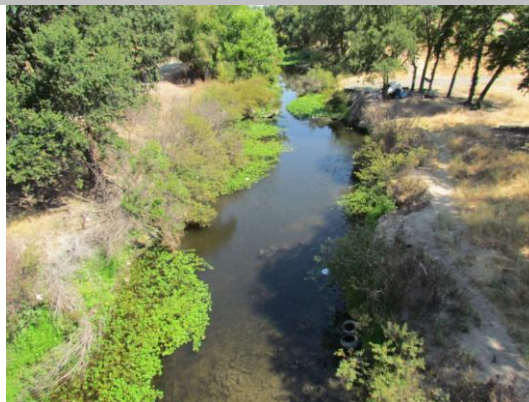
Photo 1 of 2 : ST_2014_NA0005_221_2_20140721_00011.jpg

LM Start	0.00	Rating **	A	Issue No.	2
LM End	0.00	Issue Type +	Ma	Location *	
Category	Structures & Concrete Lined Channels			GPS Latitude/Longitude	
				Start	End
Item	Vegetation & Obstructions			38.611365 °	38.611365 °
				-121.466557 °	-121.466557 °
DWR ID	DWR_NA0005_221_t_2012_2				
Action/Comments					
Inspector Comments: The channel appeared to be free of any vegetation growth.

View of the channel under the bridge. The picture was taken looking upstream.

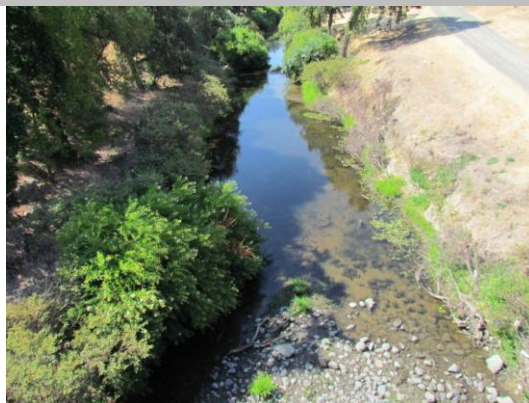
Photo 2 of 2 : ST_2014_NA0005_221_2_20140721_00012.jpg

LM Start	0.00	Rating **	A	Issue No.	2 (cont)	
LM End	0.00	Issue Type +	Ma	Location *		
Category	Structures & Concrete Lined Channels			GPS Latitude/Longitude		
				Start		End
Item	Vegetation & Obstructions			38.611365 °		38.611365 °
				-121.466557 °		-121.466557 °
DWR ID	DWR_NA0005_221_t_2012_2					
Action/Comments						
Inspector Comments: The channel appeared to be free of any vegetation growth.

View of the channel under the bridge. The picture was taken looking downstream.

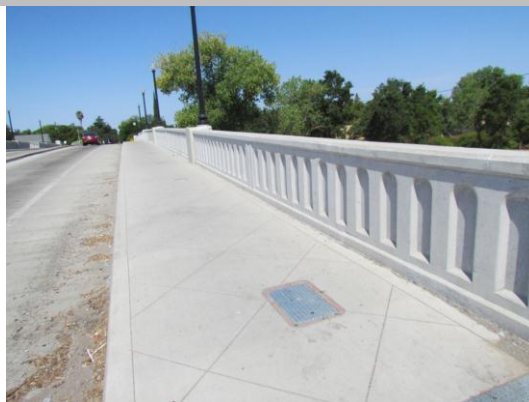
Photo 1 of 3 : ST_2014_NA0005_221_15_20140721_00013.jpg

LM Start	0.00	Rating **	A	Issue No.	15
LM End	0.00	Issue Type +	Ma	Location *	
Category	Structures & Concrete Lined Channels			GPS Latitude/Longitude	
				Start	End
Item	Concrete Surfaces			38.611365 °	38.611365 °
				-121.466557 °	-121.466557 °
DWR ID	DWR_NA0005_221_t_2012_15				
Action/Comments					
Inspector Comments: The concrete surface didn't have any spalling or cracking which would threaten the integrity of the bridge.

View of the flood wall.

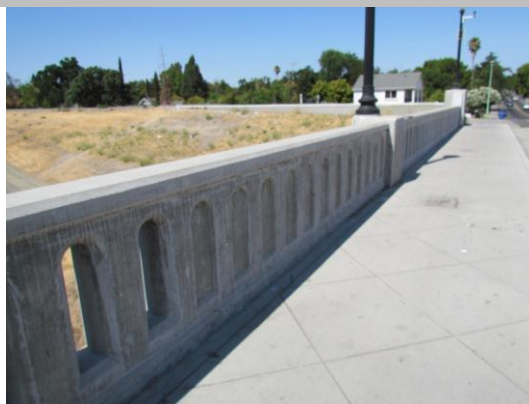
Photo 2 of 3 : ST_2014_NA0005_221_15_20140721_00014.jpg

View of the flood wall.

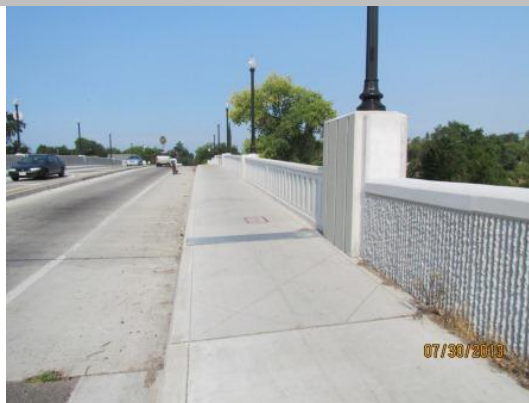
Photo 3 of 3 : ST_2014_NA0005_221_15_20140709_00005.jpg

LM Start	0.00	Rating **	A	Issue No.	15 (cont)
LM End	0.00	Issue Type +	Ma	Location *	
Category	Structures & Concrete Lined Channels			GPS Latitude/Longitude	
				Start	End
Item	Concrete Surfaces			38.611365 °	38.611365 °
				-121.466557 °	-121.466557 °
DWR ID	DWR_NA0005_221_t_2012_15				
Action/Comments					
Inspector Comments: The concrete surface didn't have any spalling or

View of the flood wall.

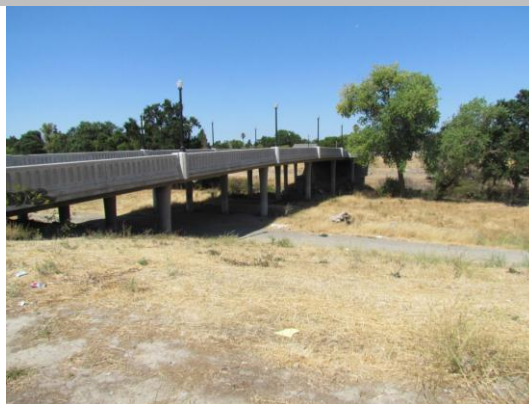
Photo 1 of 1 : ST_2014_NA0005_221_17_20140721_00015.jpg

LM Start	0.00	Rating **	A	Issue No.	17
LM End	0.00	Issue Type +	Ma	Location *	
Category	Structures & Concrete Lined Channels			GPS Latitude/Longitude	
				Start	End
Item	Concrete Foundations			38.611365 °	38.611365 °
				-121.466557 °	-121.466557 °
DWR ID	DWR_NA0005_221_t_2012_17				
Action/Comments					
Inspector Comments: No sign of scouring or erosion was visible at the footings of the structure.

View below the bridge.

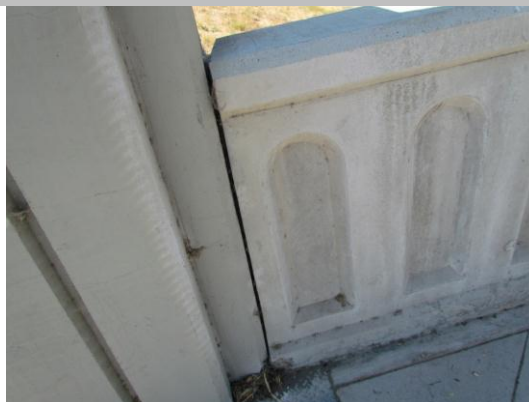
Photo 1 of 3 : ST_2014_NA0005_221_22_20140721_00016.jpg

LM Start	0.00	Rating **	A	Issue No.	22
LM End	0.00	Issue Type +	Ma	Location *	
Category	Structures & Concrete Lined Channels			GPS Latitude/Longitude	
				Start	End
Item	Monolith Joints			38.611365 °	38.611365 °
				-121.466557 °	-121.466557 °
DWR ID	DWR_NA0005_221_t_2012_22				
Action/Comments					
Inspector Comments: The monolithic joint material was in good condition on the flood walls.

View of the flood walls with monolith joints.

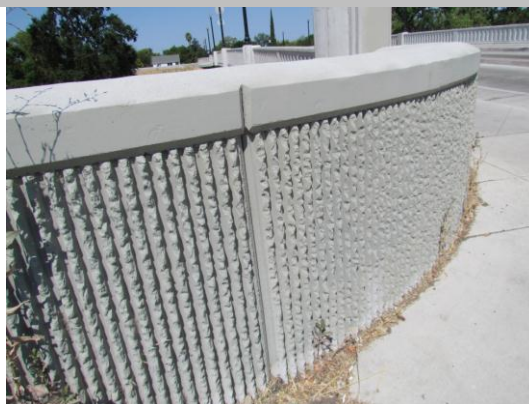
Photo 2 of 3 : ST_2014_NA0005_221_22_20140721_00017.jpg

View of the flood walls with monolith joints.

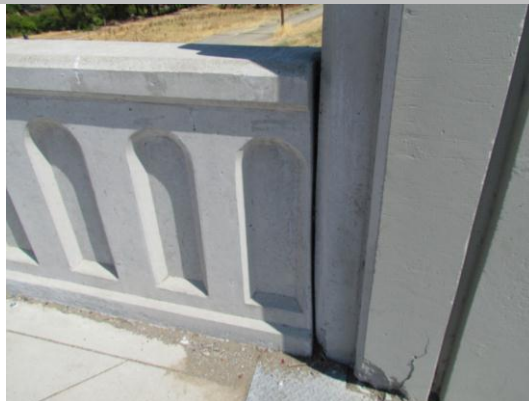
Photo 3 of 3 : ST_2014_NA0005_221_22_20140721_00018.jpg

LM Start	0.00	Rating **	A	Issue No.	22 (cont)	
LM End	0.00	Issue Type +	Ma	Location *		
Category	Structures & Concrete Lined Channels			GPS Latitude/Longitude		
				Start		End
Item	Monolith Joints			38.611365 °		38.611365 °
				-121.466557 °		-121.466557 °
DWR ID	DWR_NA0005_221_t_2012_22					
Action/Comments						
Inspector Comments: The monolithic joint material was in good

View of the flood walls with monolith joints.

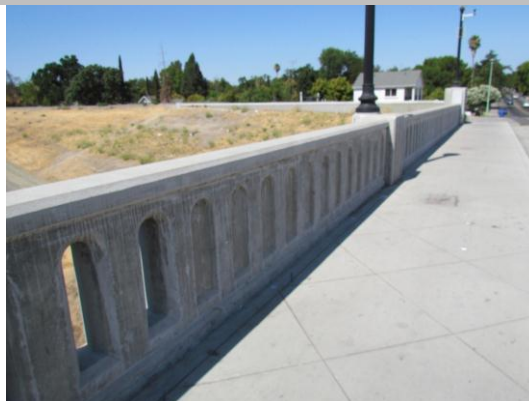
Photo 1 of 1 : ST_2014_NA0005_221_23_20140721_00019.jpg

LM Start	0.00	Rating **	A	Issue No.	23
LM End	0.00	Issue Type +	Ma	Location *	
Category	Structures & Concrete Lined Channels			GPS Latitude/Longitude	
				Start	End
Item	Safety			38.611365 °	38.611365 °
				-121.466557 °	-121.466557 °
DWR ID	DWR_NA0005_221_t_2012_23				
Action/Comments					
Inspector Comments: The walls around the structure provide adequate protection against fall hazards.

View of the flood walls which also provides protection against fall hazards.

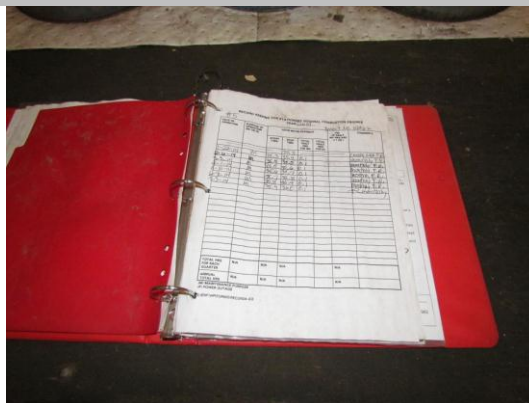
Photo 1 of 1 : ST_2014_NA0005_16_1_20140721_00020.jpg

LM Start	0.00	Rating **	A	Issue No.	1
LM End	0.00	Issue Type +	Ma	Location *	
Category	Pump Stations			GPS Latitude/Longitude	
				Start	End
Item	Operating Log			38.640967 °	38.640967 °
				-121.471106 °	-121.471106 °
DWR ID	DWR_NA0005_16_t_2012_1				
Action/Comments					
Inspector Comments: The operation log was maintained up to date and it was present at the pump station.

View of the maintenance log in the pumping plant.

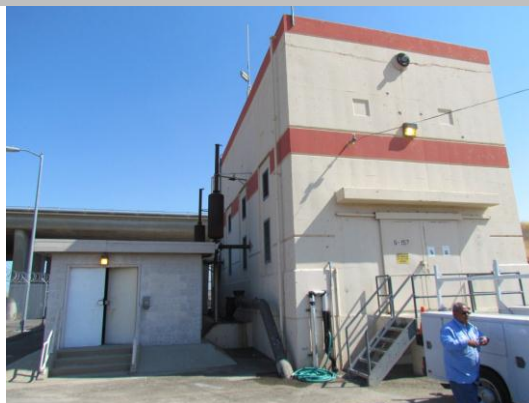
Photo 1 of 2 : ST_2014_NA0005_16_3_20140721_00021.jpg

LM Start	0.00	Rating **	A	Issue No.	3
LM End	0.00	Issue Type +	Ma	Location *	
Category	Pump Stations			GPS Latitude/Longitude	
				Start	End
Item	Plant Building			38.640967 °	38.640967 °
				-121.471106 °	-121.471106 °
DWR ID	DWR_NA0005_16_t_2012_3				
Action/Comments					
Inspector Comments: The plant building was in good condition without any visible cracks or structural damage.

View of the pumping plant and the control room.

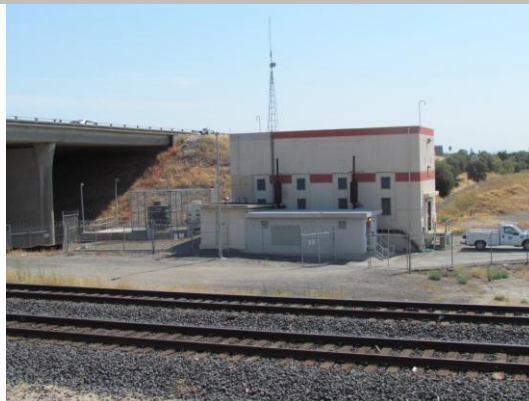
Photo 2 of 2 : ST_2014_NA0005_16_3_20140721_00036.jpg

LM Start	0.00	Rating **	A	Issue No.	3 (cont)	
LM End	0.00	Issue Type +	Ma	Location *		
Category	Pump Stations			GPS Latitude/Longitude		
				Start		End
Item	Plant Building			38.640967 °		38.640967 °
				-121.471106 °		-121.471106 °
DWR ID	DWR_NA0005_16_t_2012_3					
Action/Comments						
Inspector Comments: The plant building was in good condition without any visible cracks or structural damage.

An alternate view of the pumping plant.

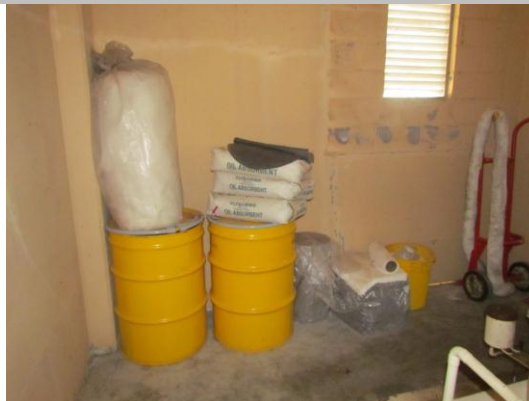
Photo 1 of 2 : ST_2014_NA0005_16_5_20140721_00022.jpg

LM Start	0.00	Rating **	A	Issue No.	5
LM End	0.00	Issue Type +	Ma	Location *	
Category	Pump Stations			GPS Latitude/Longitude	
				Start	End
Item	Safety			38.640967 °	38.640967 °
				-121.471106 °	-121.471106 °
DWR ID	DWR_NA0005_16_t_2012_5				
Action/Comments					
Inspector Comments: The building didn't have visible safety issues. Fire extinguishers were present inside the building along with material for oil spills.

Safety material for oil spills was present inside the pumping plant.

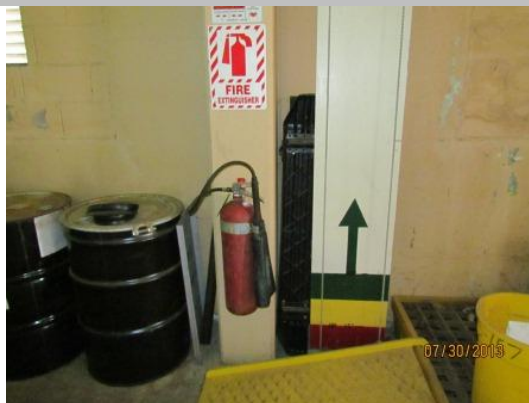
Photo 2 of 2 : ST_2014_NA0005_16_5_20140709_00004.jpg

LM Start	0.00	Rating **	A	Issue No.	5 (cont)	
LM End	0.00	Issue Type +	Ma	Location *		
Category	Pump Stations			GPS Latitude/Longitude		
				Start	End	
Item	Safety			38.640967 °	38.640967 °	
				-121.471106 °	-121.471106 °	
DWR ID	DWR_NA0005_16_t_2012_5					
Action/Comments						
Inspector Comments: The building didn't have visible safety issues. Fire extinguishers were present inside the building along with material for oil spills.

View of the fire extinguisher inside the pumping plant.

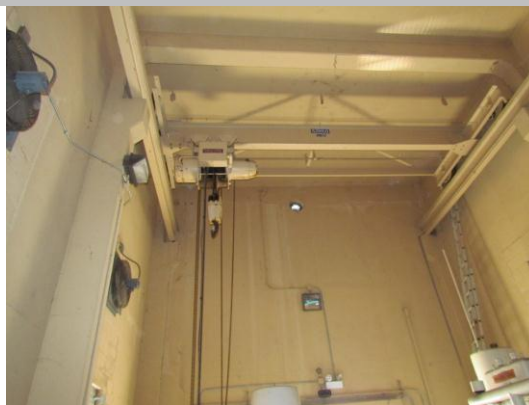
Photo 1 of 1 : ST_2014_NA0005_16_6_20140721_00023.jpg

LM Start	0.00	Rating **	A	Issue No.	6
LM End	0.00	Issue Type +	Ma	Location *	
Category	Pump Stations			GPS Latitude/Longitude	
				Start	End
Item	Cranes			38.640967 °	38.640967 °
				-121.471106 °	-121.471106 °
DWR ID	DWR_NA0005_16_t_2012_6				
Action/Comments					
Inspector Comments: The crane appeared to be in good working condition inside the pumping plant.

View of the crane inside the pumping plant.

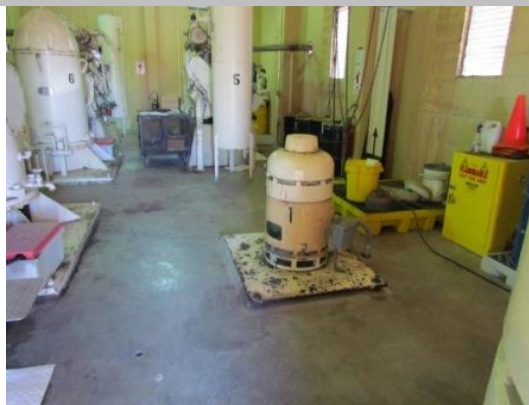
Photo 1 of 4 : ST_2014_NA0005_16_7_20140709_00007.jpg

LM Start	0.00	Rating **	A	Issue No.	7
LM End	0.00	Issue Type +	Ma	Location *	
Category	Pump Stations			GPS Latitude/Longitude	
				Start	End
Item	Pumps			38.640967 °	38.640967 °
				-121.471106 °	-121.471106 °
DWR ID	DWR_NA0005_16_t_2012_7				
Action/Comments					
Inspector Comments: The pumps didn't show any signs of corrosion and all the pumps appeared to be properly maintained and periodically tested.

View of one of the electric pumps inside the plant.

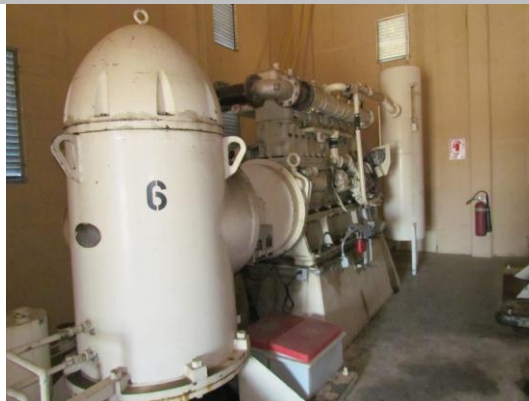
Photo 2 of 4 : ST_2014_NA0005_16_7_20140721_00024.jpg

LM Start	0.00	Rating **	A	Issue No.	7 (cont)	
LM End	0.00	Issue Type +	Ma	Location *		
Category	Pump Stations			GPS Latitude/Longitude		
				Start	End	
Item	Pumps			38.640967 °	38.640967 °	
				-121.471106 °	-121.471106 °	
DWR ID	DWR_NA0005_16_t_2012_7					
Action/Comments						
Inspector Comments: The pumps didn't show any signs of corrosion and all the pumps appeared to be properly maintained and periodically tested.

View of one of the propane powered pumps inside the plant.

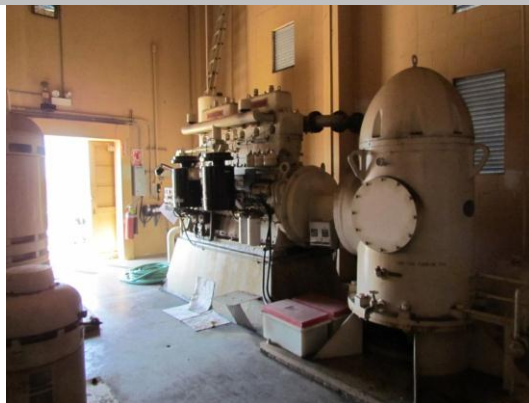
Photo 3 of 4 : ST_2014_NA0005_16_7_20140721_00025.jpg

View of another propane powered pumps inside the plant.

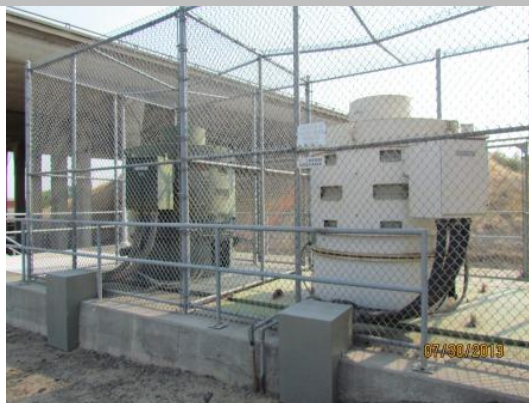
Photo 4 of 4 : ST_2014_NA0005_16_7_20140709_00008.jpg

View of the electric pumps outside of the pumping plant.

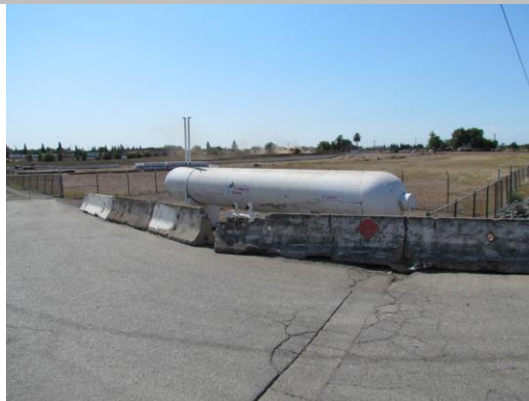
Photo 1 of 2 : ST_2014_NA0005_16_8_20140721_00026.jpg

LM Start	0.00	Rating **	A	Issue No.	8	
LM End	0.00	Issue Type +	Ma	Location *		
Category	Pump Stations			GPS Latitude/Longitude		
				Start	End	
Item	Power			38.640967 °	38.640967 °	
				-121.471106 °	-121.471106 °	
DWR ID	DWR_NA0005_16_t_2012_8					
Action/Comments						
Inspector Comments: The power sources appeared to be safe and

View of the propane tank outside the pumping plant.

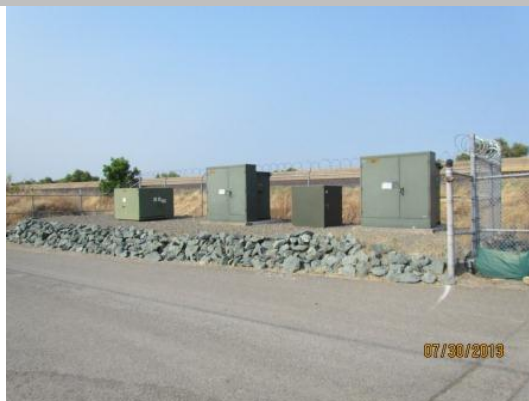
Photo 2 of 2 : ST_2014_NA0005_16_8_20140709_00011.jpg

View of the electrical boxes outside the pumping plant.

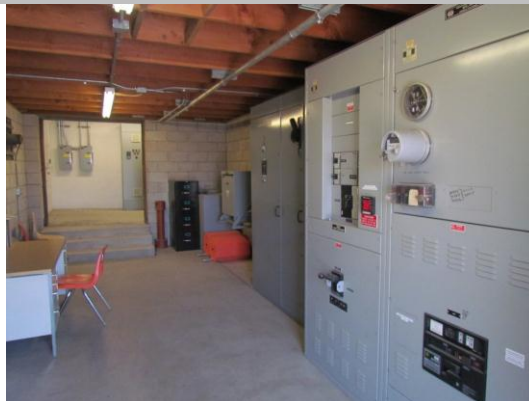
Photo 1 of 2 : ST_2014_NA0005_16_11_20140721_00027.jpg

LM Start	0.00	Rating **	A	Issue No.	11
LM End	0.00	Issue Type +	Ma	Location *	
Category	Pump Stations			GPS Latitude/Longitude	
				Start	End
Item	Pump Control Systems			38.640967 °	38.640967 °
				-121.471106 °	-121.471106 °
DWR ID	DWR_NA0005_16_t_2012_11				
Action/Comments					
Inspector Comments: All the pump control systems appeared to be in a good condition.

View of the pump control systems in the pump control building.

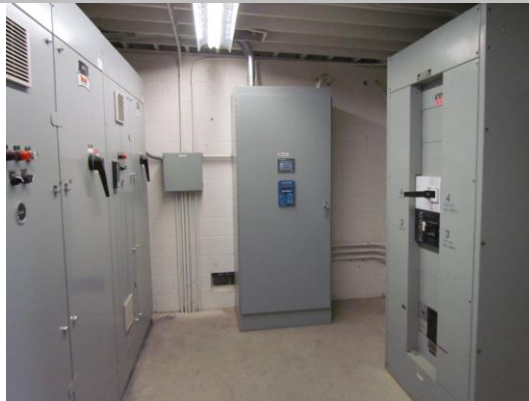
Photo 2 of 2 : ST_2014_NA0005_16_11_20140721_00028.jpg

View of the pump control systems inside the control building.

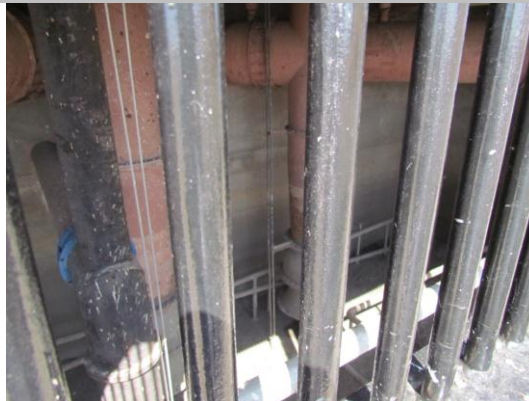
Photo 1 of 1 : ST_2014_NA0005_16_12_20140721_00030.jpg

LM Start	0.00	Rating **	A	Issue No.	12
LM End	0.00	Issue Type +	Ma	Location *	
Category	Pump Stations			GPS Latitude/Longitude	
				Start	End
Item	Sumps/Wet Well			38.640967 °	38.640967 °
				-121.471106 °	-121.471106 °
DWR ID	DWR_NA0005_16_t_2012_12				
Action/Comments					
Inspector Comments: The wet well was clear of any debris or

View of the wet well.

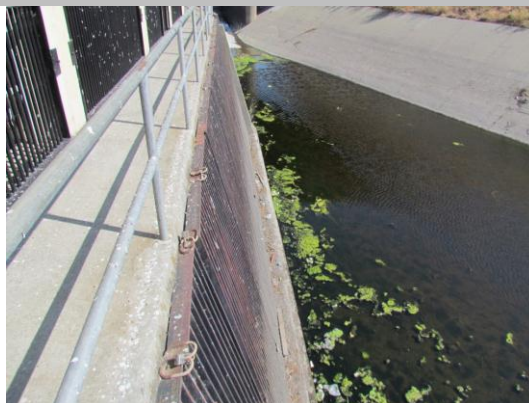
Photo 1 of 1 : ST_2014_NA0005_16_13_20140721_00031.jpg

LM Start	0.00	Rating **	A	Issue No.	13
LM End	0.00	Issue Type +	Ma	Location *	
Category	Pump Stations			GPS Latitude/Longitude	
				Start	End
Item	Trash Racks			38.640967 °	38.640967 °
				-121.471106 °	-121.471106 °
DWR ID	DWR_NA0005_16_t_2012_13				
Action/Comments					
Inspector Comments: Trash rack appeared to be clean and out of any debris.

View of the trash rack.

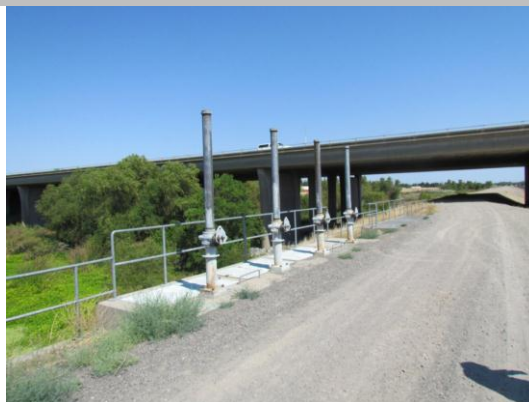
Photo 1 of 1 : ST_2014_NA0005_16_17_20140721_00032.jpg

LM Start	0.00	Rating **	A	Issue No.	17
LM End	0.00	Issue Type +	Ma	Location *	
Category	Pump Stations			GPS Latitude/Longitude	
				Start	End
Item	Manual Gate Operators			38.640967 °	38.640967 °
				-121.471106 °	-121.471106 °
DWR ID	DWR_NA0005_16_t_2012_17				
Action/Comments					
Inspector Comments: The slide gate appeared to be in good working condition.

View of the slide gate operators.

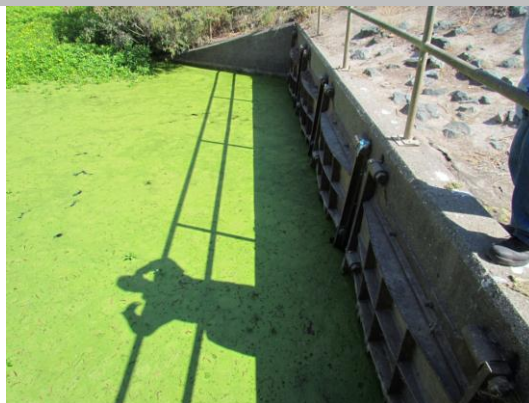
Photo 1 of 1 : ST_2014_NA0005_16_19_20140721_00033.jpg

LM Start	0.00	Rating **	A	Issue No.	19
LM End	0.00	Issue Type +	Ma	Location *	
Category	Pump Stations			GPS Latitude/Longitude	
				Start	End
Item	Flap Gates			38.640967 °	38.640967 °
				-121.471106 °	-121.471106 °
DWR ID	DWR_NA0005_16_t_2012_19				
Action/Comments					
Inspector Comments: The flap gates appeared to be in good condition and free of any obstructions.

View of the flap gates.

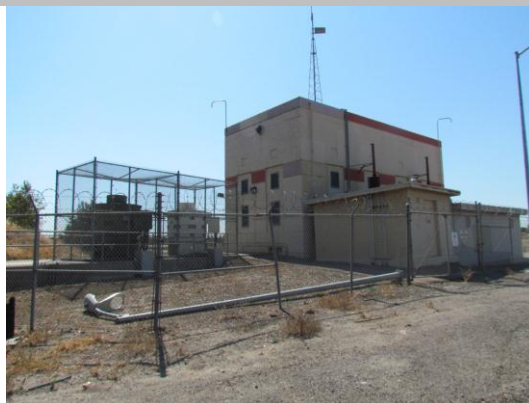
Photo 1 of 1 : ST_2014_NA0005_16_21_20140721_00034.jpg

LM Start	0.00	Rating **	A	Issue No.	21
LM End	0.00	Issue Type +	Ma	Location *	
Category	Pump Stations			GPS Latitude/Longitude	
				Start	End
Item	Security Fencing			38.640967 °	38.640967 °
				-121.471106 °	-121.471106 °
DWR ID	DWR_NA0005_16_t_2012_21				
Action/Comments					
Inspector Comments: The security fencing around the structures appeared to be in good condition and should provide protection against unauthorized access.

View of the security fencing around the structure.

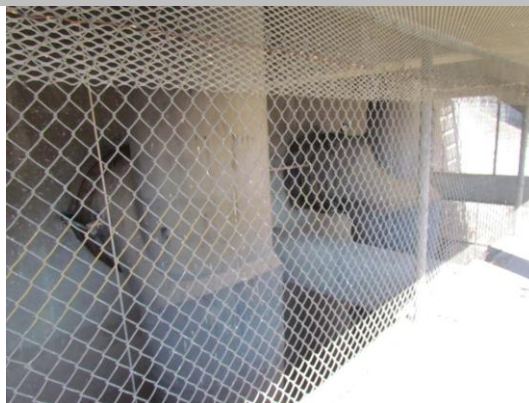
Photo 1 of 1 : ST_2014_NA0005_16_22_20140721_00035.jpg

LM Start	0.00	Rating **	A	Issue No.	22
LM End	0.00	Issue Type +	Ma	Location *	
Category	Pump Stations			GPS Latitude/Longitude	
				Start	End
Item	Intake and Discharge Pipes			38.640967 °	38.640967 °
				-121.471106 °	-121.471106 °
DWR ID	DWR_NA0005_16_t_2012_22				
Action/Comments					
Inspector Comments: The intake pipes appeared to be in good condition.

View of the intake pipes.
